Front-End Misalignments and MEBT Trajectory

Stuart Henderson

April 8, 2003

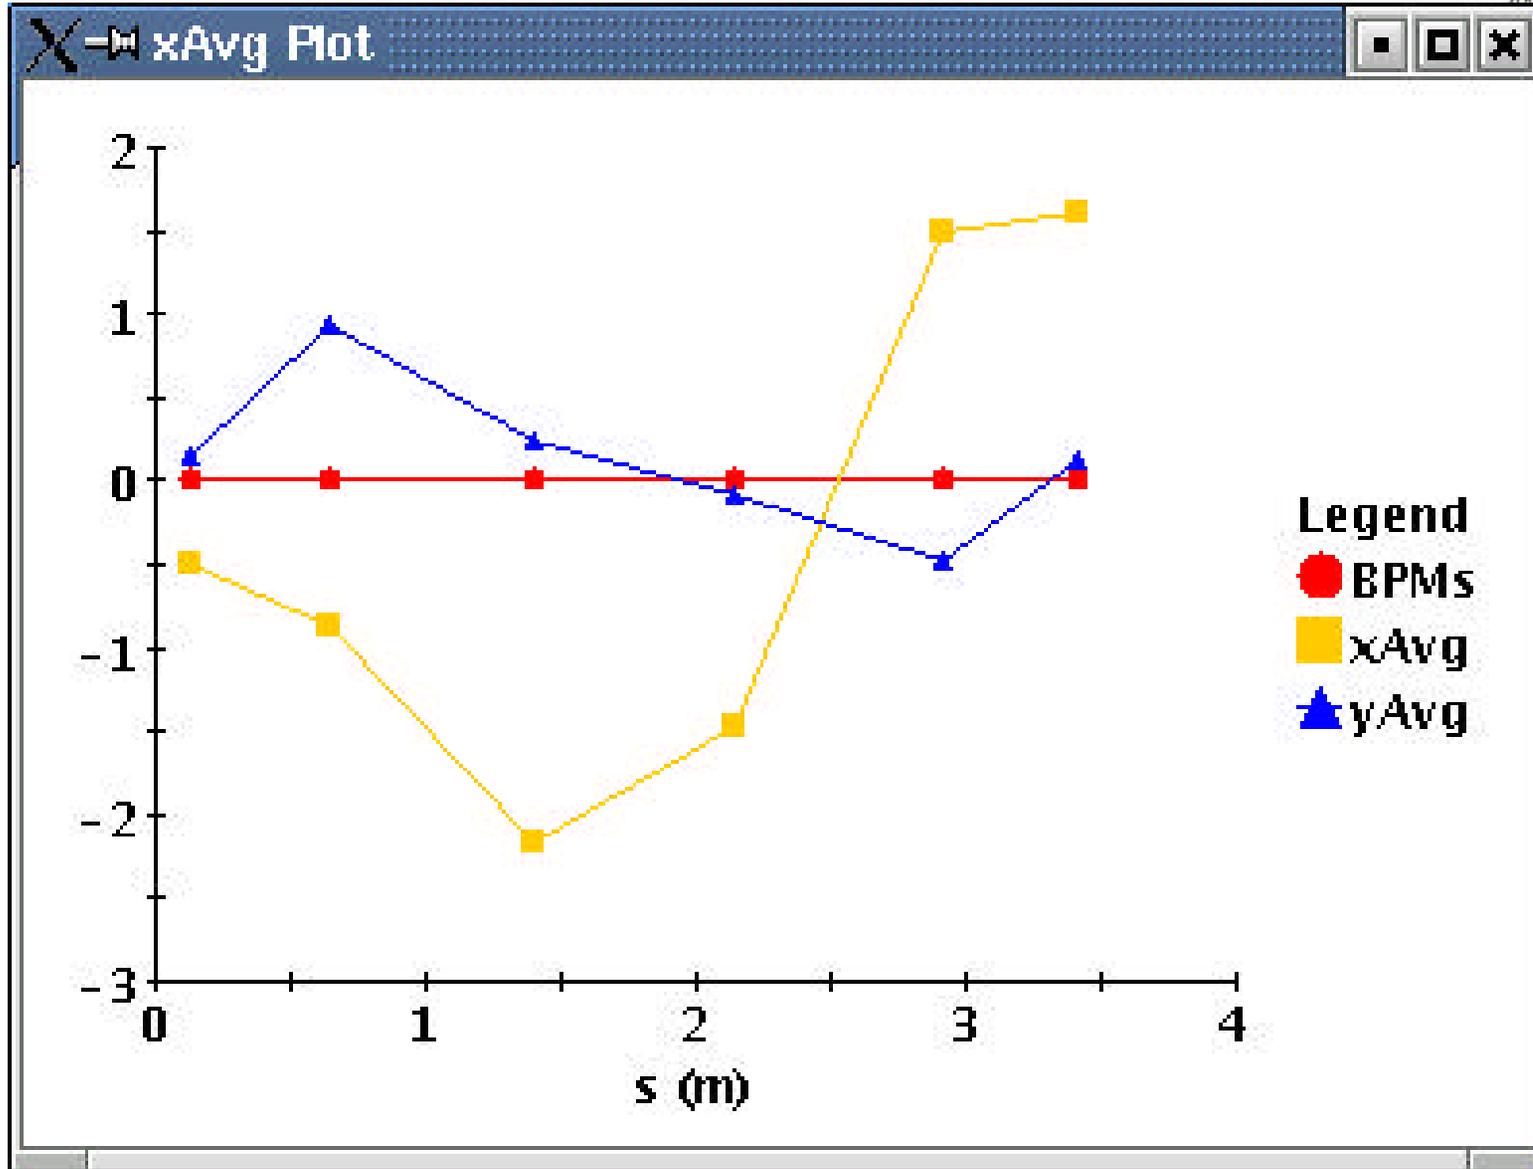
Typical MEBT Trajectory with LEBT/MEBT Correctors Off

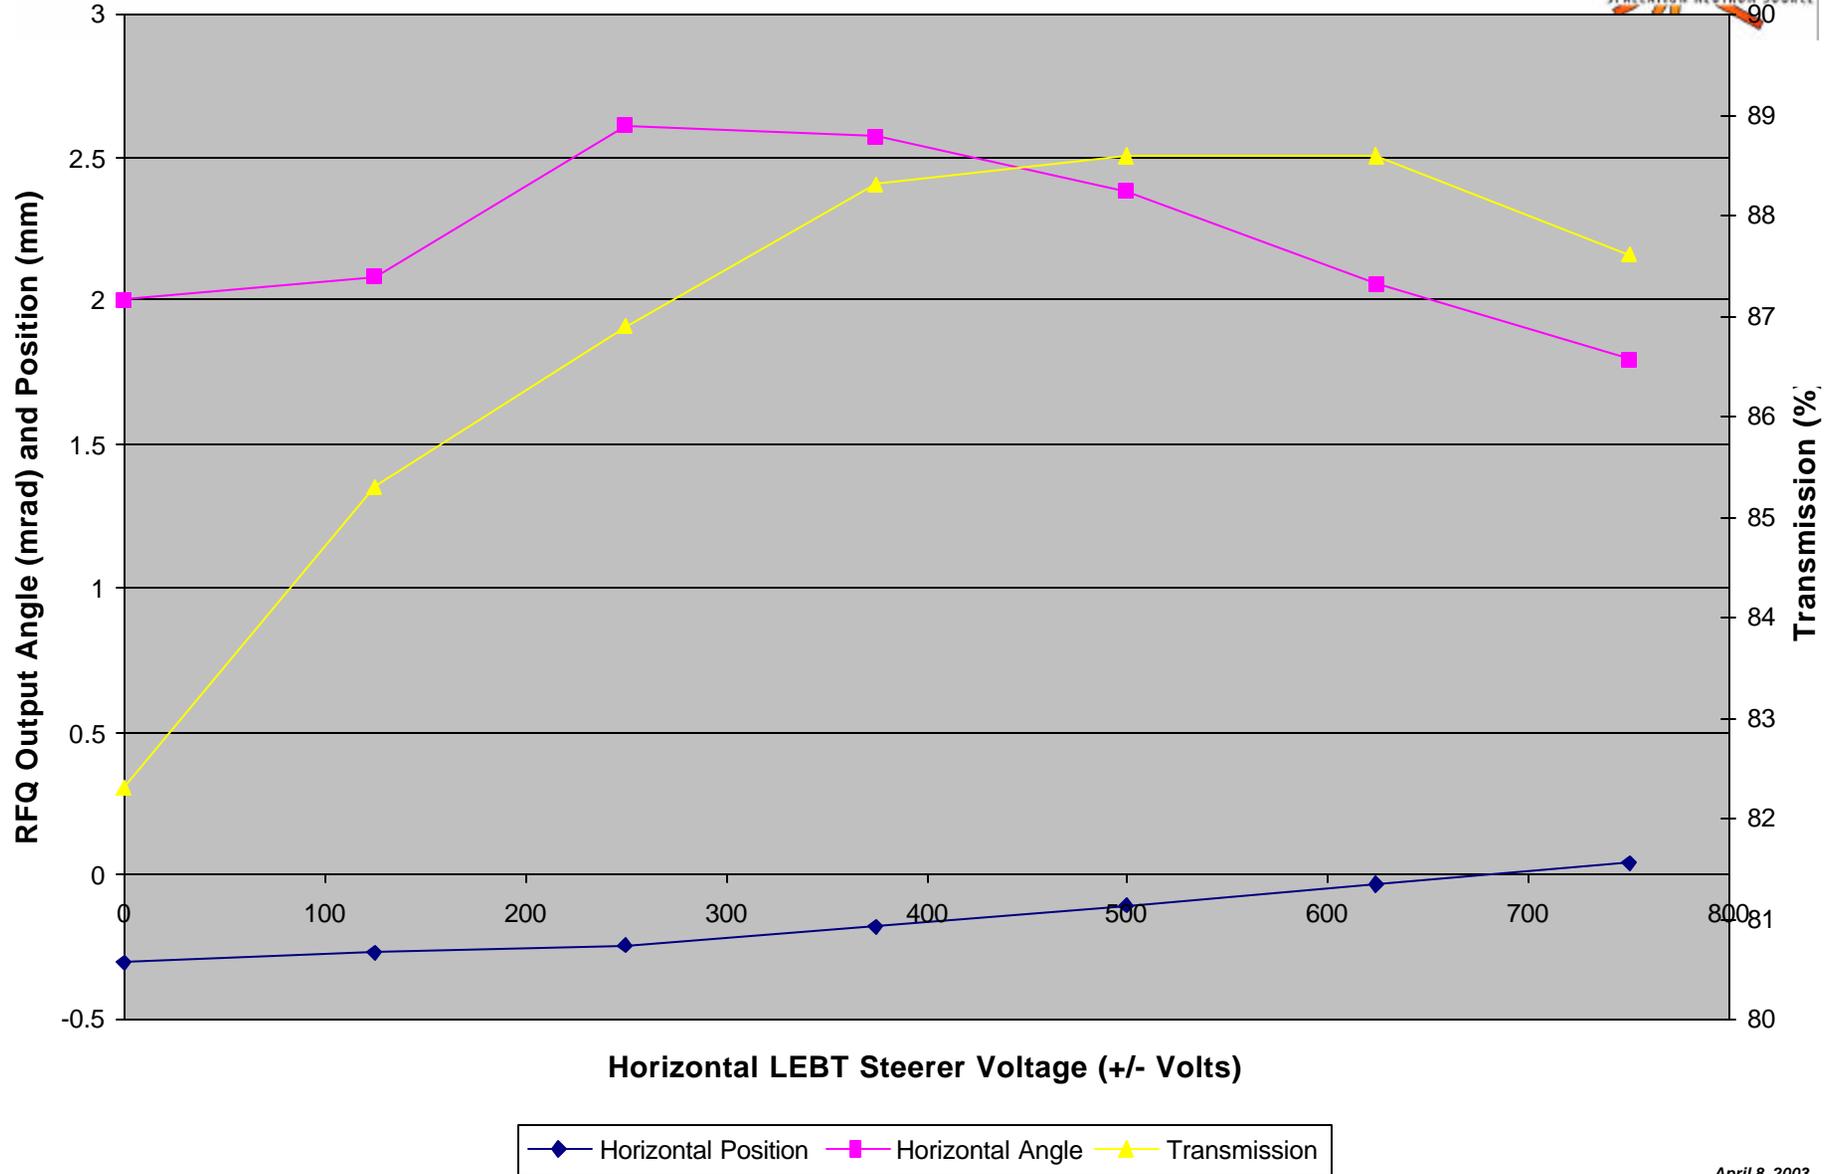
$$\Delta x = -1.12 \text{ mm} \quad \Delta y = -0.81 \text{ mm}$$

RFQ Output for Measured LEBT/RFQ Misalignment vs. Horizontal LEBT Steering

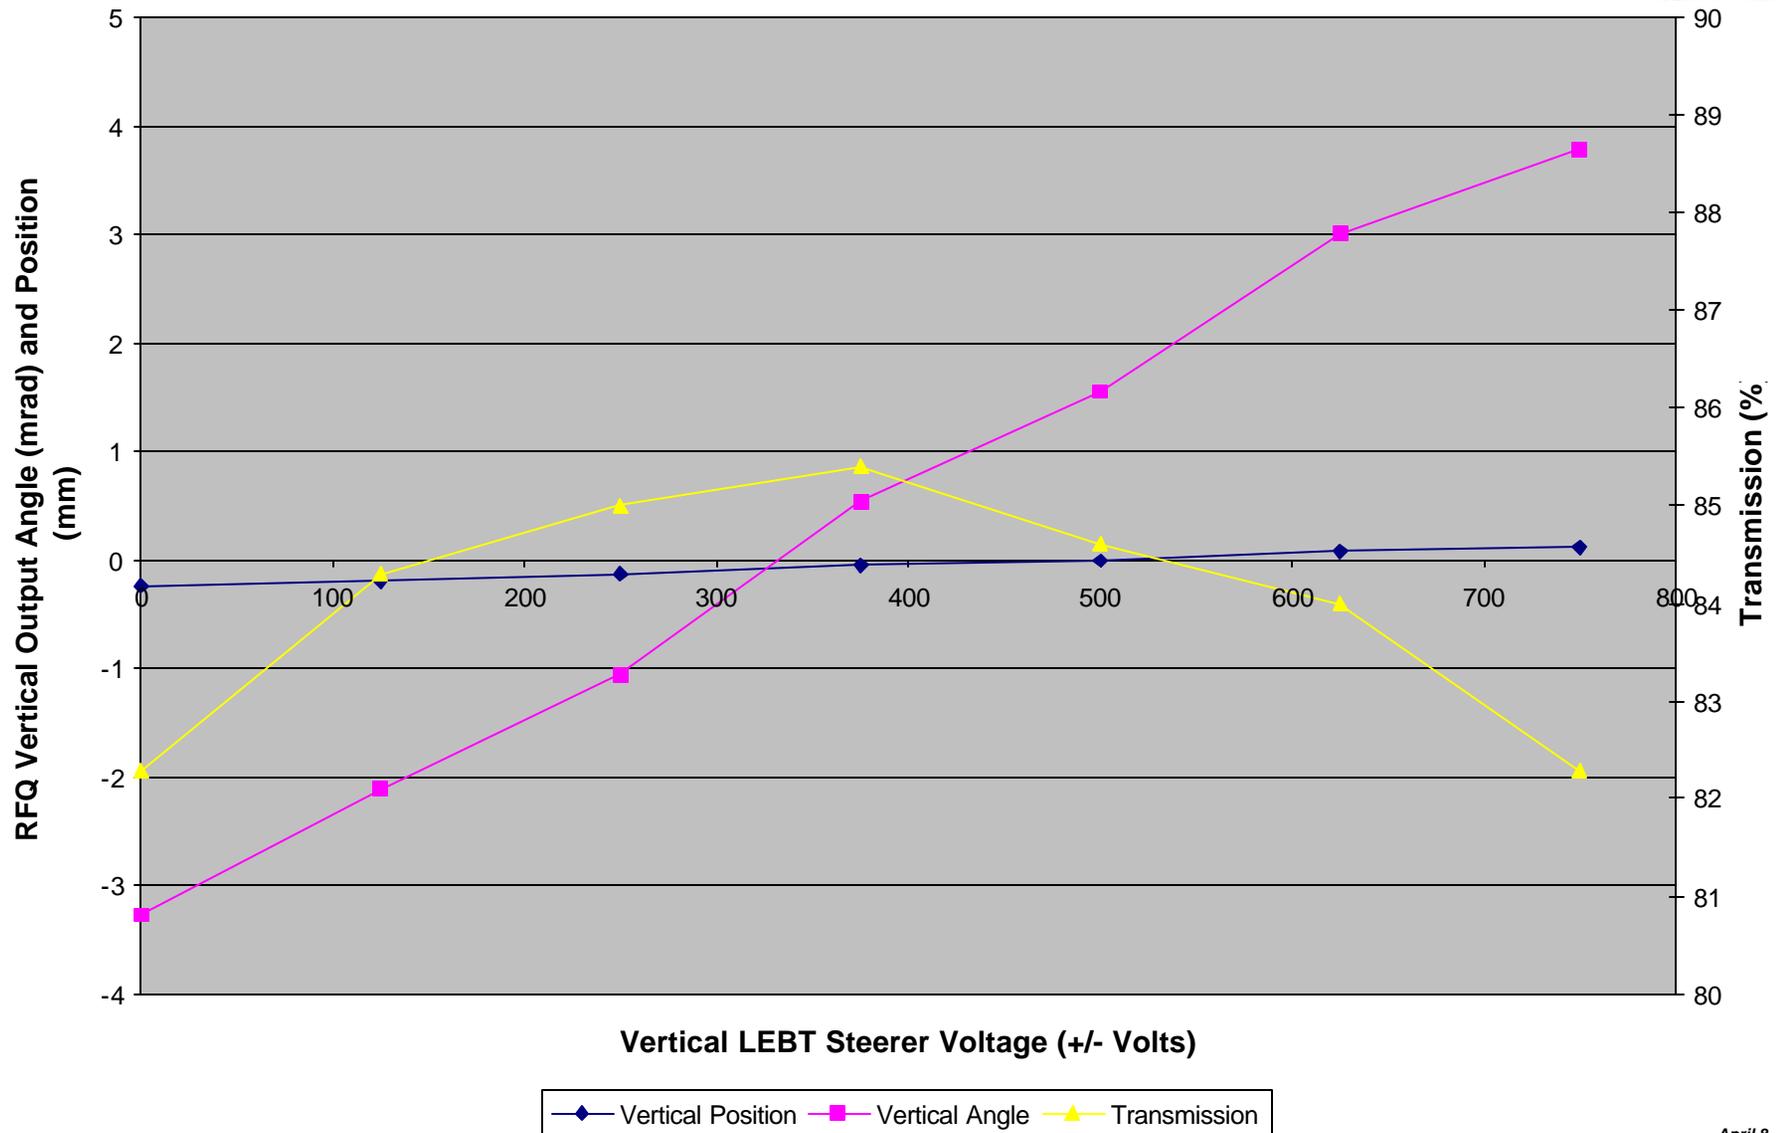
RFQ Output for Measured LEBT/RFQ Misalignment vs. Vertical LEBT Steering

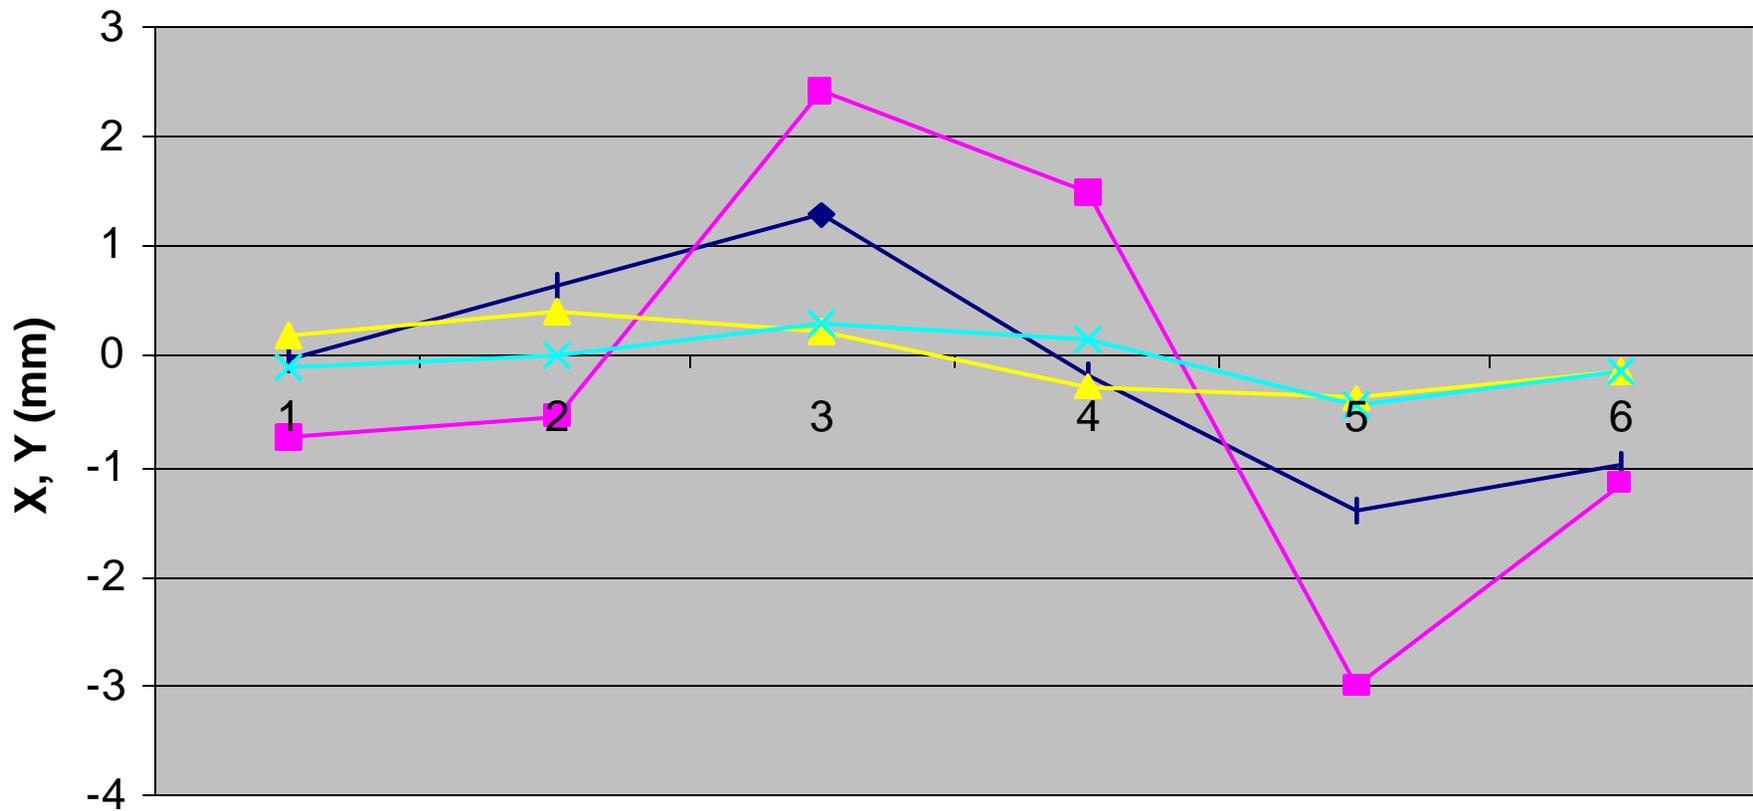
Predicted MEBT Trajectories with IS/LEBT Misalignment

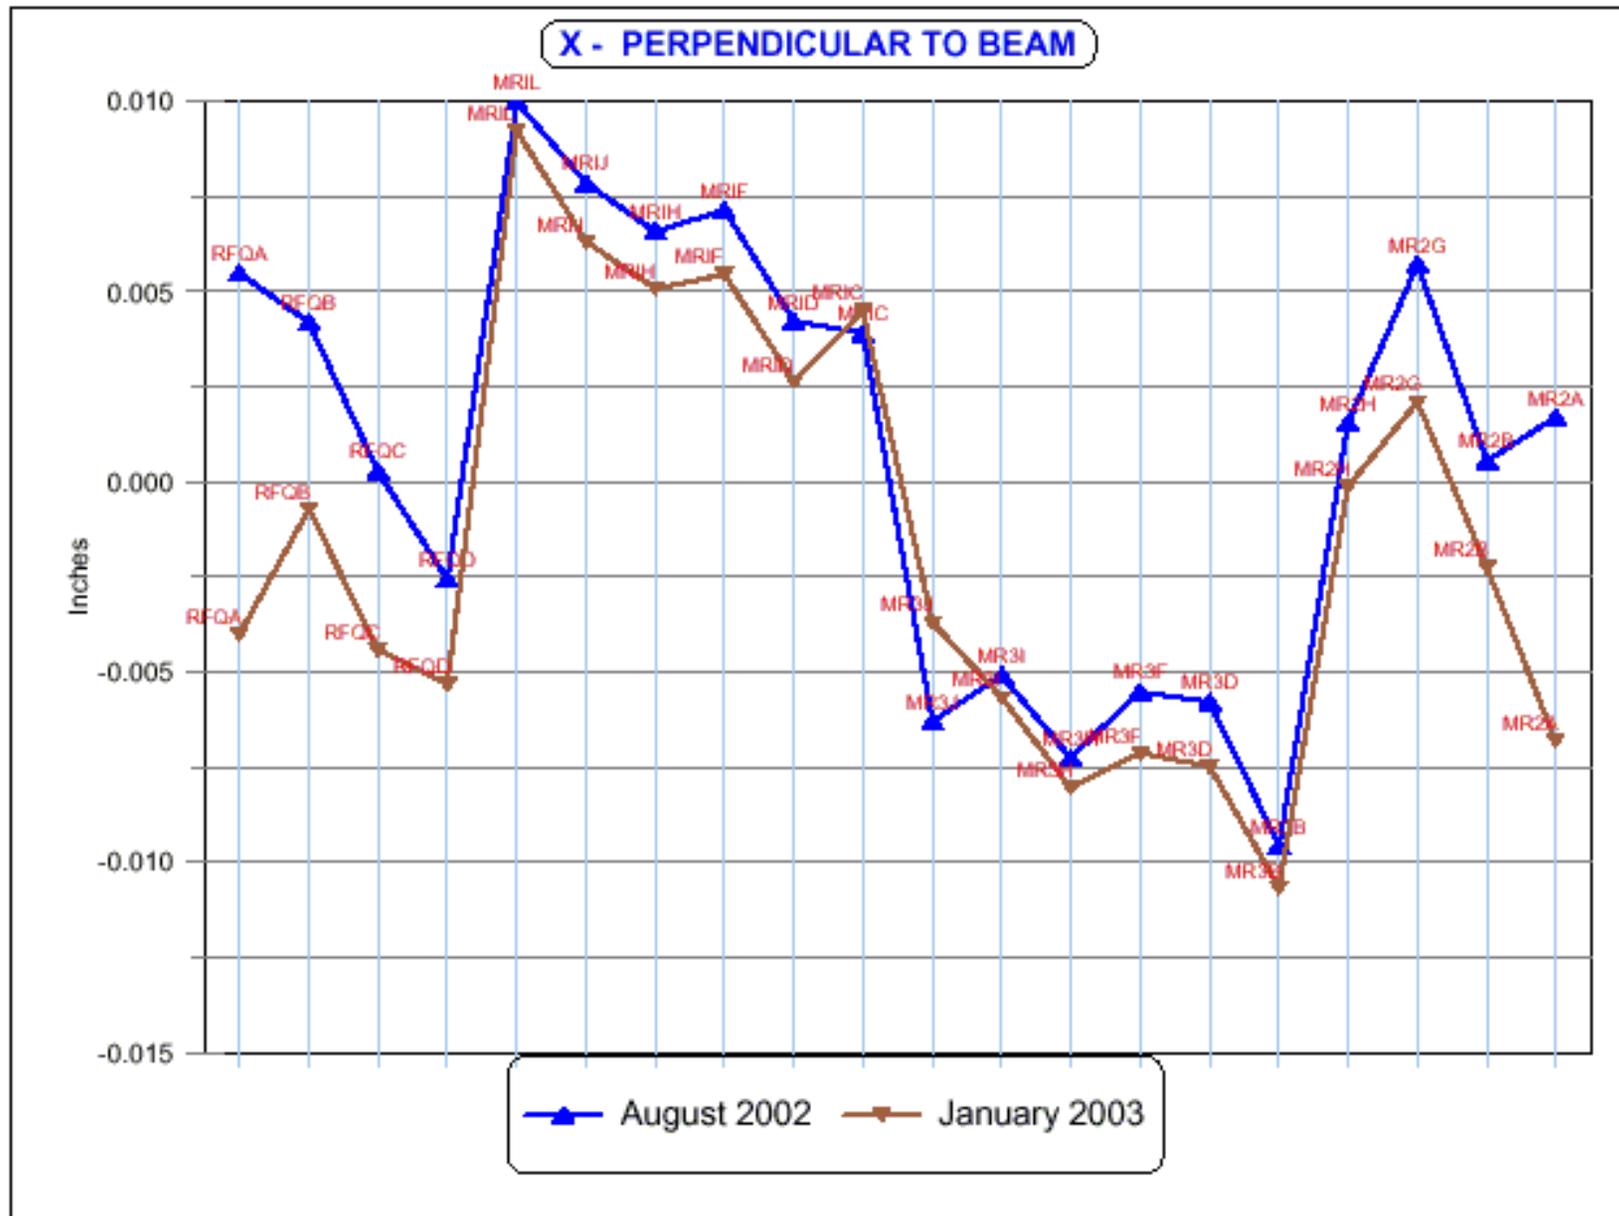
Problem #2: MEBT was misaligned

Horizontal Front-End Survey

- Two misalignments at work:
 - IS/LEBT to RFQ misalignment
 - MEBT Raft misalignments nearly an order of magnitude greater than parameter list
- Solution:
 - IS/LEBT, RFQ, MEBT, DTL1 will be re-aligned (Error et. al.)
 - LEBT Flange adjustment with set-screws (Stockli et. al.)
 - Fixed MEBT corrector controls problem that lead to PS oscillation (Elec, Controls groups)
- Qualitative agreement between simulation and measurements using measured misalignments

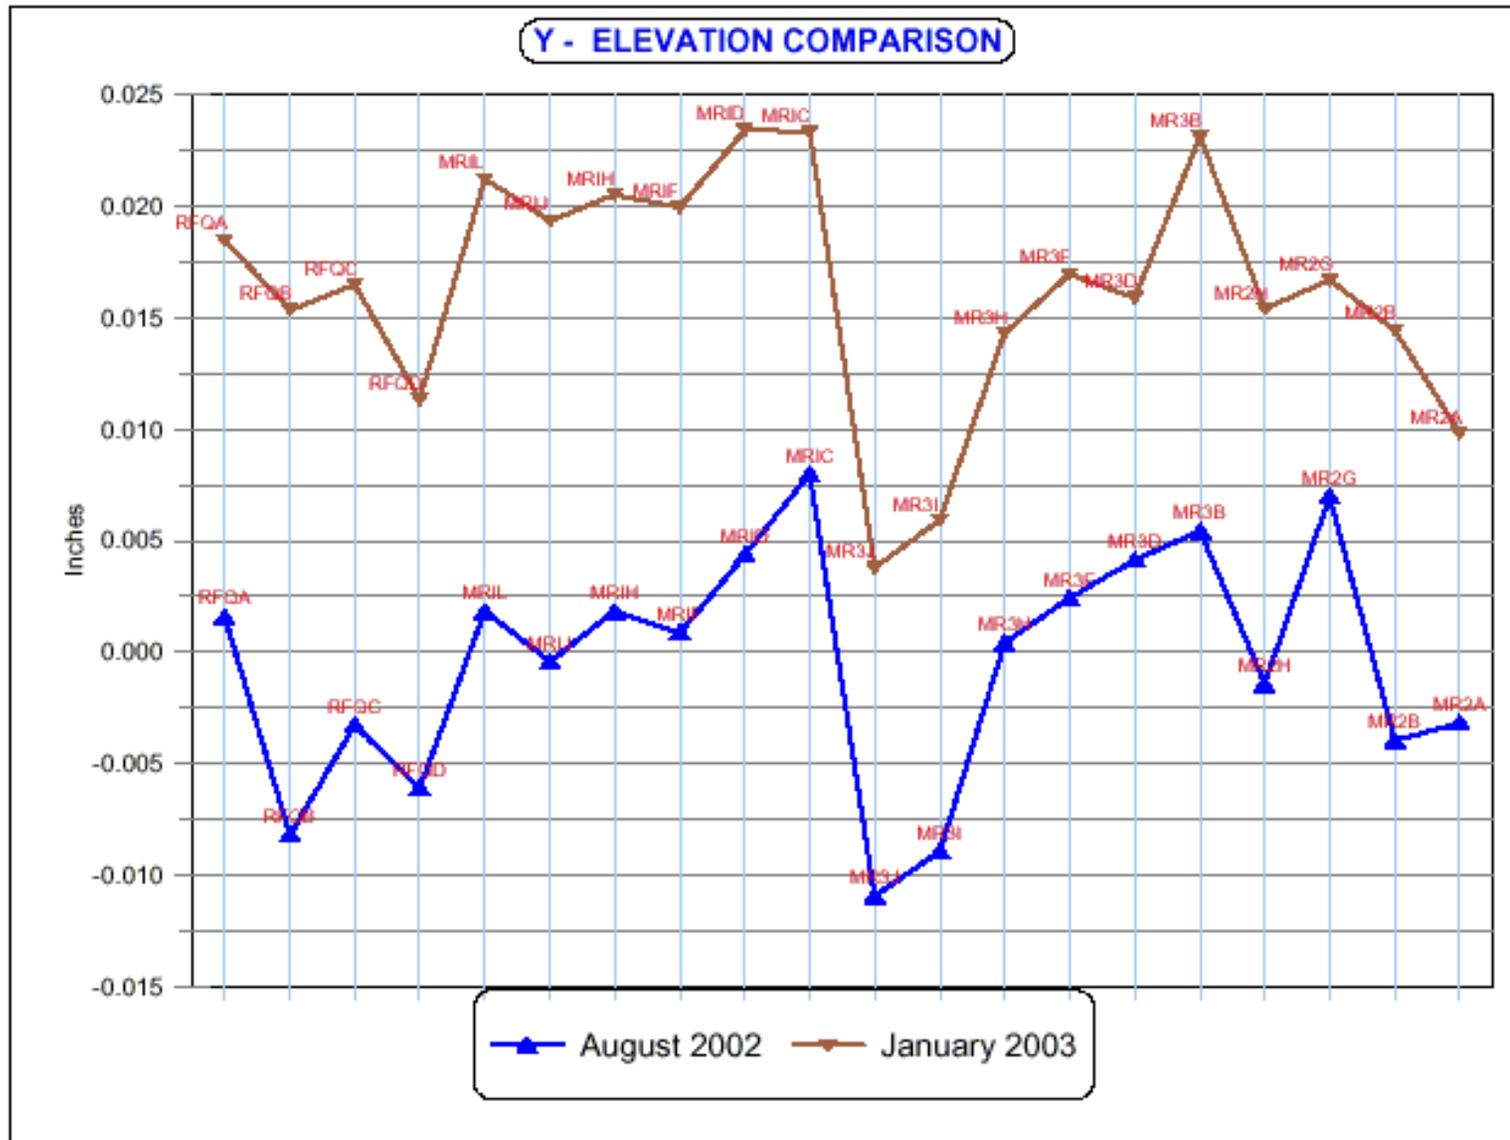
Vertical Front-End Survey

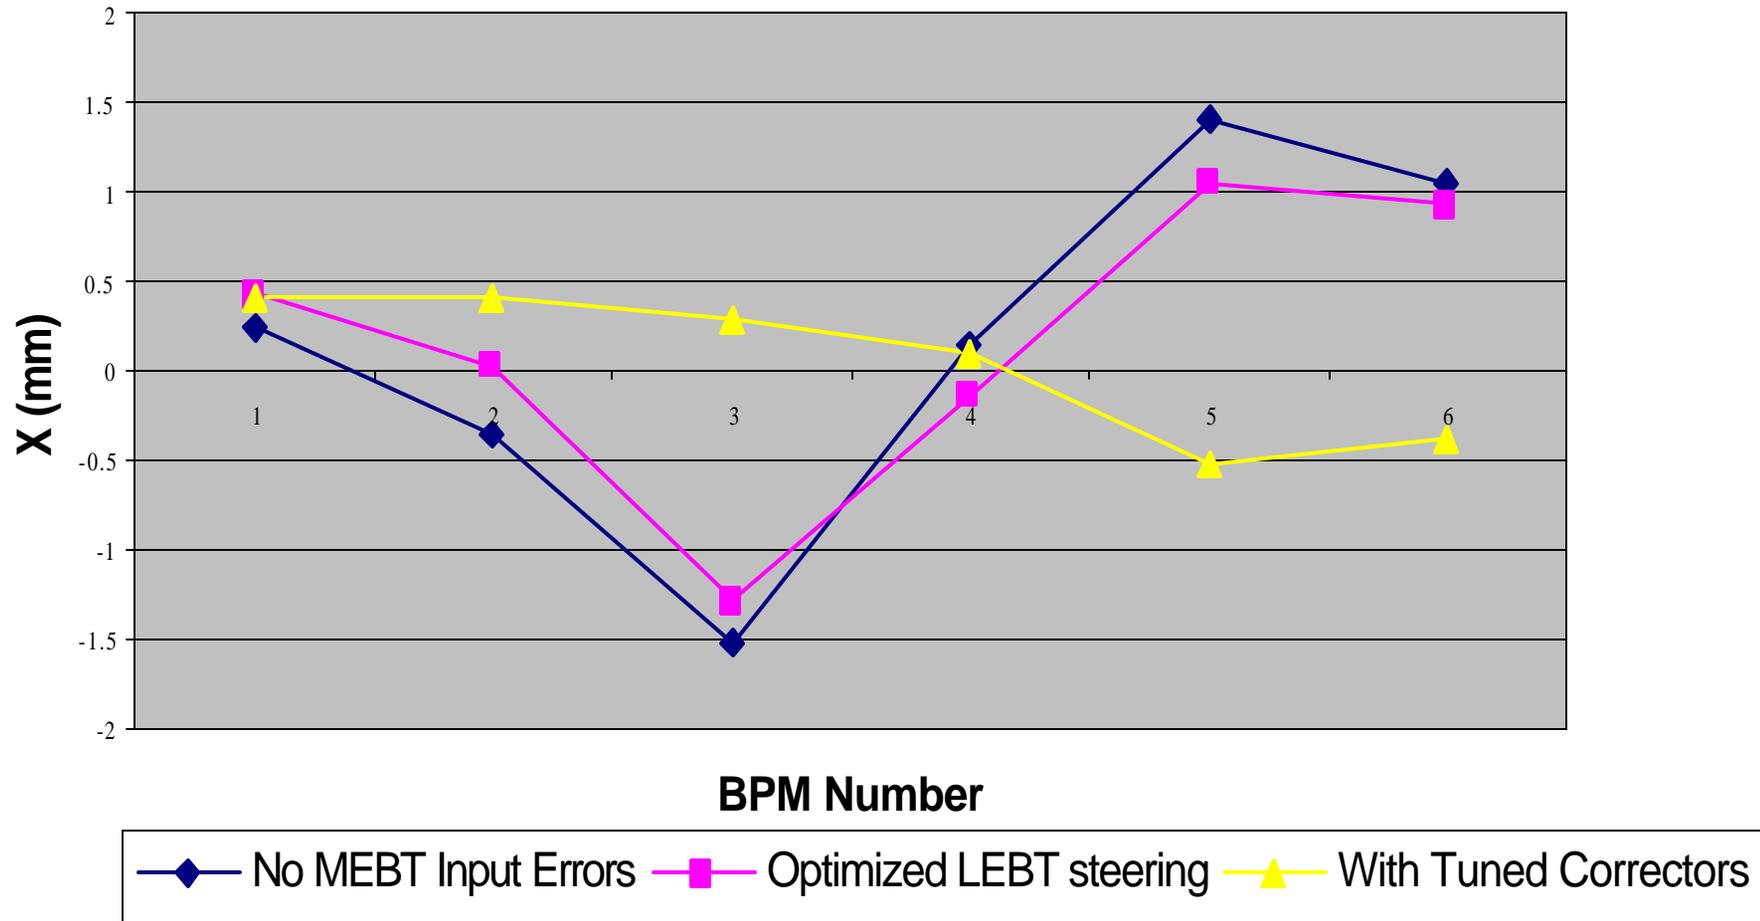
MEBT Trajectories with misaligned rafts

Horizontal MEBT Trajectories

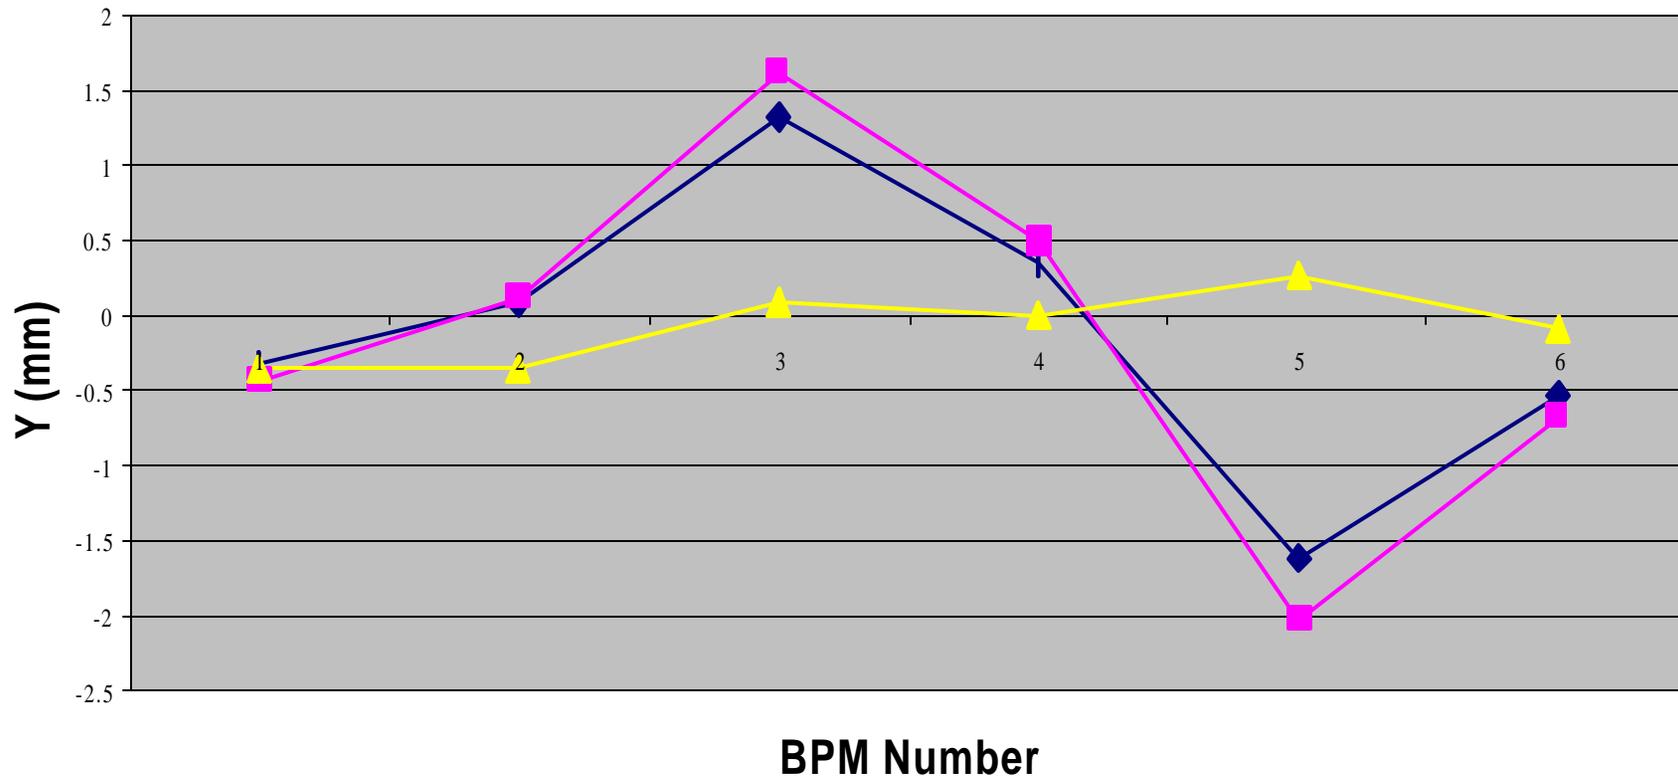
MEBT Trajectories with misaligned rafts

Vertical MEBT Trajectories
